# PROPERTY INSPECTION REPORT

Sukhrali Village, Sector 17, Gurugram, Haryana 122001

Date of Inspection: 9/15/2023 Time: 11:50am

Age of Home: 10 Years Size: 312 sq.ft.

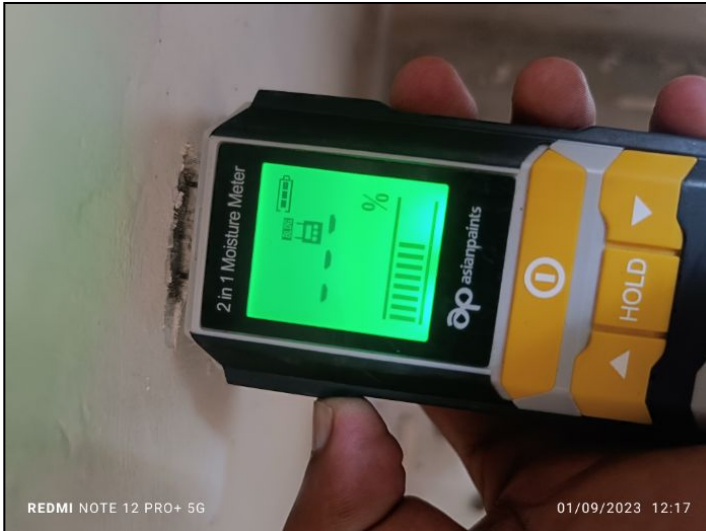
High moisture was noted on office front wall

- # Re-paint Recommendation- After the moisture issues has been resolved and walls have become completely dry, please follow below mentioned steps for paint work.

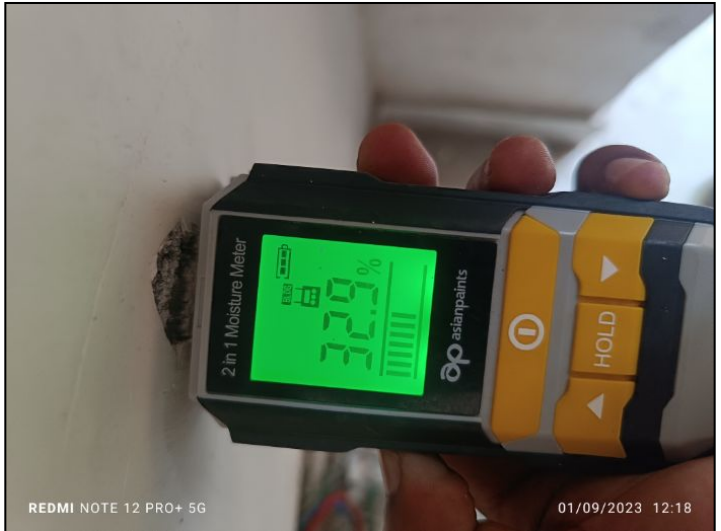
High moisture was noted on office fornt wall

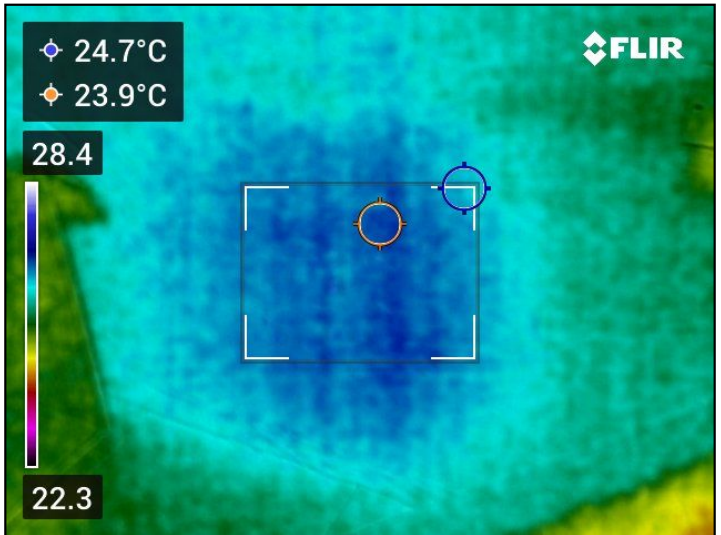
IR image of moisture on office inside fornt wall

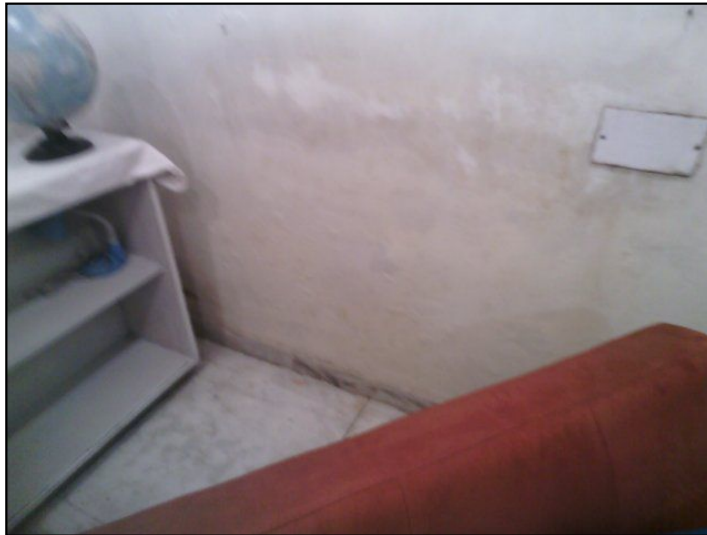
Visual image of moisture on office inside front wall

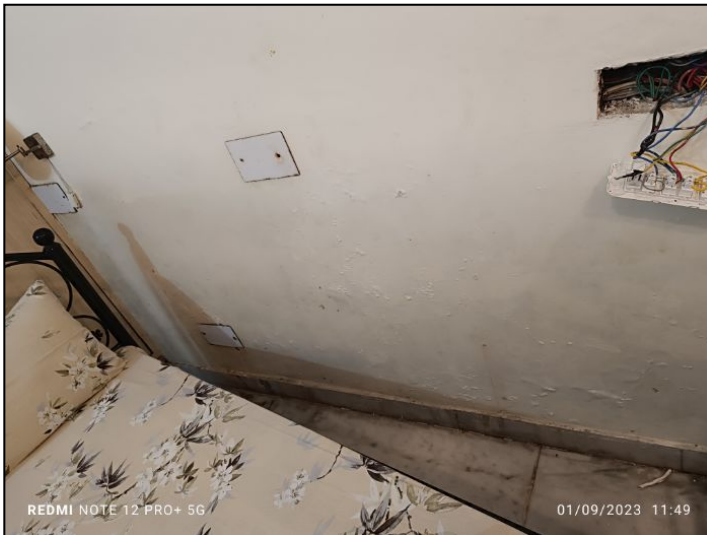
Moisture was noted on left wall

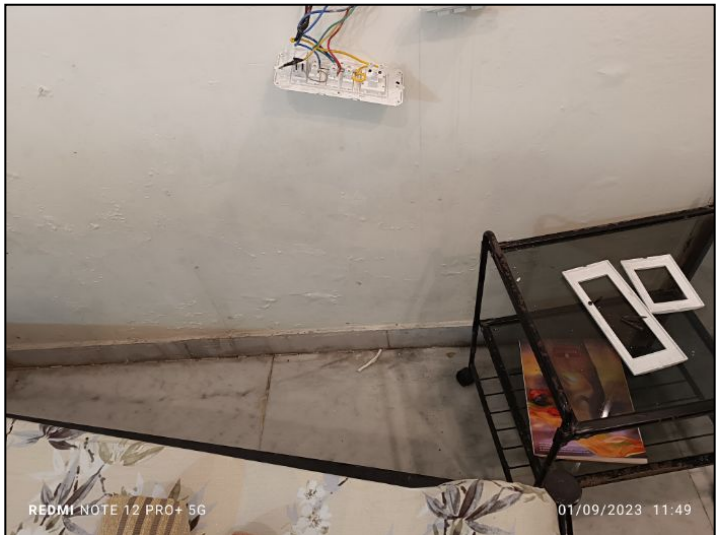
Moisture was noted on back wall

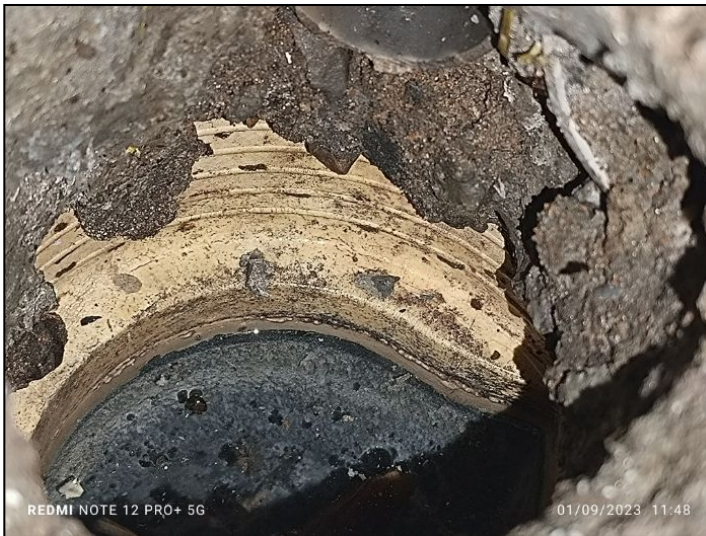
PVC Sleeve was not installed inside the drain

3. PVC sleeve should be installed in the main drain and it should be properly connected with a PVC pipe to multi trap and N- Trap.
4. This way there will be no seepage of water happening outside the pipe drain channel.

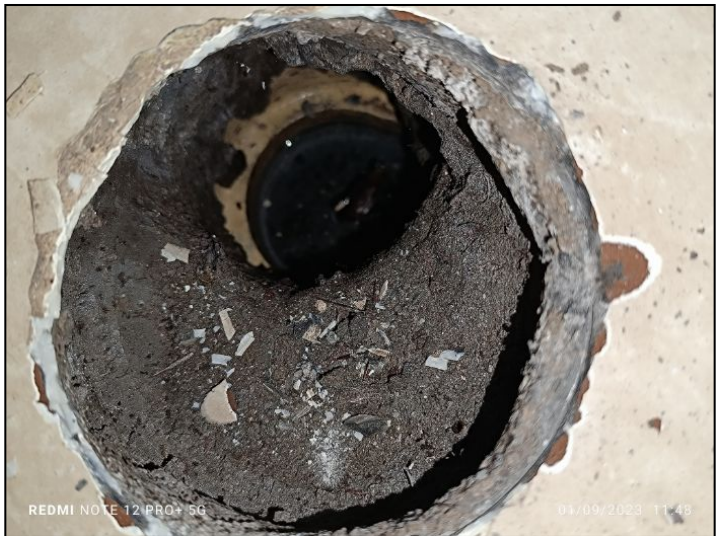
Improper installation of drain pipe

1. Stone should be cut at approx 1ft \* 1ft and flooring should be dug until the pipes are connecting inside the floor with main drains in washroom.
2. Washbasin drain pipe should be connecting it to Multi-trap (as per requirement- 2 way, 3 way) to be installed in the main drain.
