# PROPERTY INSPECTION REPORT

Sukhrali Village, Sector 17, Gurugram, Haryana 122001

Date of Inspection: 9/15/2023 Time: 11:50am

Age of Home: 10 Years Size: 312 sq.ft.

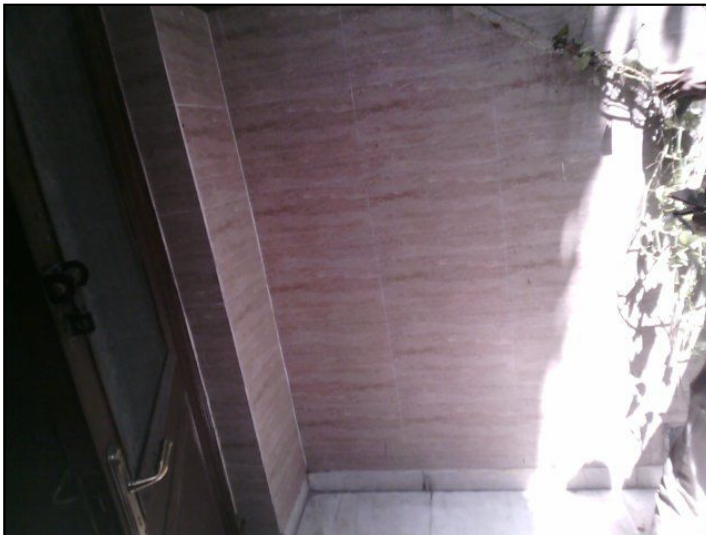
- 1. Moisture was noted on office inside front wall due to grouting issue.
- 2. **PVC** sleeve was not installed in the drain.
- 3. Improper grouting was noted wall and flooring in the balcony area.

High moisture was noted on office fornt wall

- # Re-paint Recommendation- After the moisture issues has been resolved and walls have become completely dry, please follow below mentioned steps for paint work.

Step-7: Apply final paint over it after a duration of minimum 15 days and let dry it for 48 hours. Please note-the above recommendation should be followed only after all plumbing leakages have been resolved
